Replacing Restorations Using Pressed Lithium Disilicate

Esthetics, durability, and functionality anywhere in the mouth

Rafael Santrich, CDT

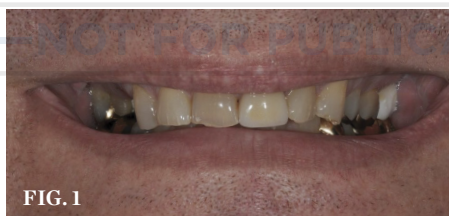
The patient exhibited a fracture on tooth No. 5, tooth No. 3 was broken, and he had an overall loss of vertical dimension due to bruxism (Figure 1 through Figure 3). At the same time, the patient opted to restore his worn anterior dentition to correct the wear and produce a more esthetic smile. A treatment plan was discussed with the patient that involved replacing the cast gold restorations with IPS e.max Press lithium disilicate crowns due to their strength, durability, and esthetics.

CASE PRESENTATION (1.) Preoperative view of the patient. **(2.)** Close-up of preoperative view showing the visible fracture of tooth No. 5. **(3.)** Occlusal preoperative view.

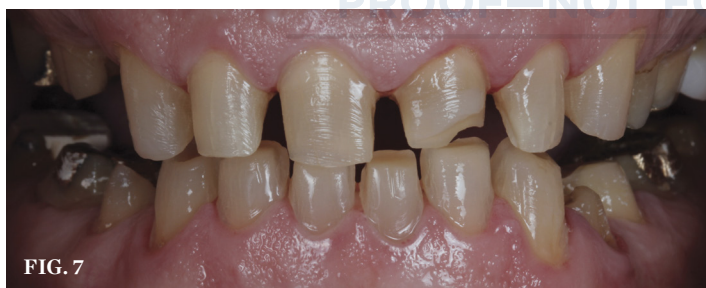
FIG. 7

TREATMENT PROGRESSION (4.) A diagnostic wax-up was created. **(5.)** Right lateral view of the diagnostic wax-up. **(6.)** Left lateral view of the diagnostic wax-up. **(7.)** The affected teeth were prepared. **(8.)** A clear, vacuum shelf was molded to create temporary restorations. **(9. AND 10.)** Upper and lower temporaries were placed.

A diagnostic wax-up of the patient's proposed restorations was made (Figure 4 through Figure 6). The patient's teeth were prepared (Figure 7), and a clear, vacuum shelf was molded on the diagnostic wax-up for creating the temporary crowns for the patient. The vacuum shelf was placed in the patient's mouth to verify fit (Figure 8), after which the provisional restorations

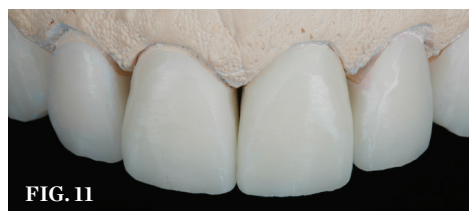
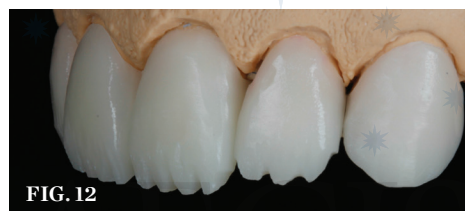
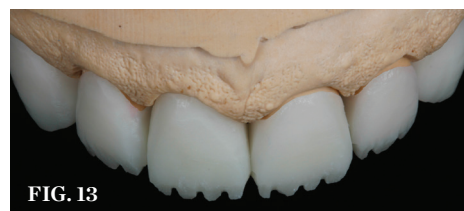
CASE COMPLETION (11. AND 12.) The full-contour anterior crown restorations were cut back slightly on the incisal portion to allow for artistic modification. **(14.)** Essence stains were applied to the crowns, which were then fired at 810°C. **(15. THROUGH 17.)** A series of IPS e.max Ceram powders were applied to complete the incisal characterization, after which the crowns were fired at 750°C. **(18. THROUGH 20.)** The definitive crowns were tried in, cleaned with Ivoclean, and cemented with Variolink luting composite according to the manufacturer's instructions. **(21. AND 22.)** IPS e.max Press veneers were placed on teeth No. 22 through No. 27, and a NobelActive implant was inserted for tooth No. 3.

The full-contour anterior veneers were then cut back slightly on the incisal portion to allow room for artistic modification (Figure 11 through Figure 13). Stains and glaze paste were then applied to the crowns to create
