USING PRESSED LITHIUM DISILICATE TO REPLACE CAST GOLD RESTORATIONS

High-strength esthetic materials ensure optimal fit, function, and patient satisfaction

Rafael Santrich, CDT

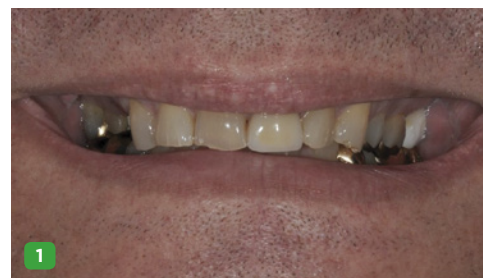
Fig 1. Preoperative view of the patient.

The patient exhibited a fracture on tooth No. 5, tooth No. 3 was broken, and he had an overall loss of vertical dimension due to bruxism (Figure 1 through Figure 3). A treatment plan was discussed with the patient that involved replacing the cast gold restorations with IPS e.max Press lithium disilicate crowns due to their strength, durability, and esthetics.

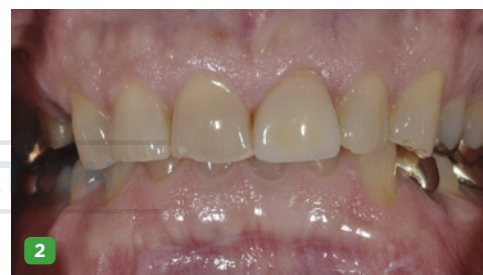
Fig 2. Close-up of preoperative view showing the visible fracture of tooth No. 5.

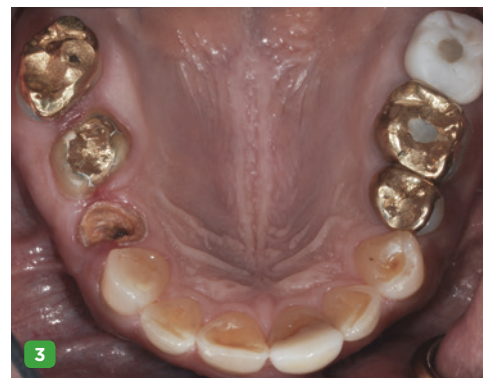
Fig 3. Occlusal preoperative view.

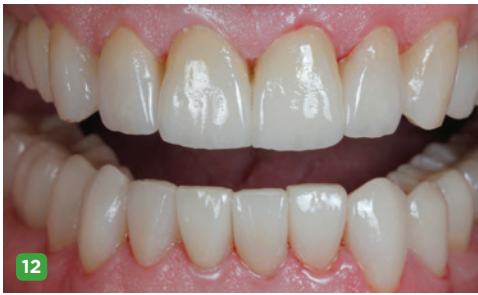
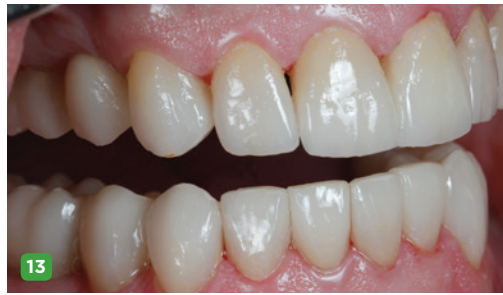
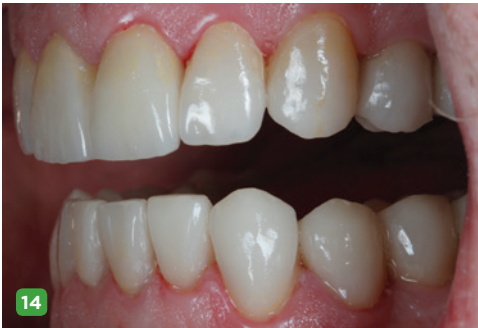
Fig 12 through Fig 14. The definitive crowns were tried in, cleaned with Ivoclean, and cemented with Variolink luting composite according to the manufacturer's instructions.

The temporary restorations were removed and the preparations were cleaned. The final restorations were tried in, then cleaned with Ivoclean (Ivoclar Vivadent) The crowns were loaded with Variolink® luting composite (Ivoclar Vivadent), seated onto the preparations, and light cured according to the manufacturer's instructions. All excess cement was removed (Figure 12 through Figure 14v). IPS e.max Press lithium disilicate veneers (Ivoclar Vivadent) were placed on teeth No. 22 through No. 27, and a NobelActive™ implant (Nobel Biocare, www.nobelbiocare.com) was inserted for tooth No. 3.

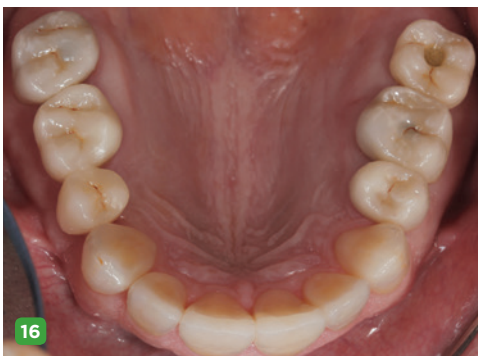
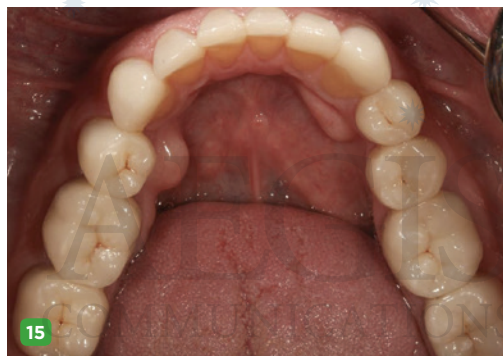
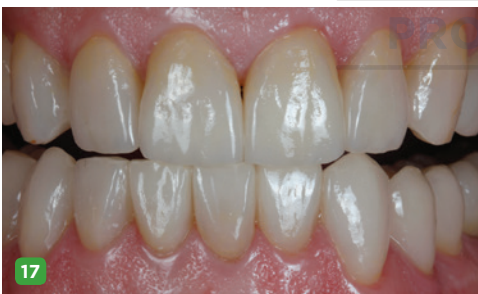
Fig 15 through Fig 17. IPS e.max Press veneers were placed on teeth No. 22 through No. 27, and a NobelActive implant was inserted for tooth No. 3.

Twenty days after cementation, the patient was examined at a recall appointment. He had no discomfort or sensitivity, and the restorations displayed remarkably life-like esthetics, fit, and function (Figure 15 through Figure 18).

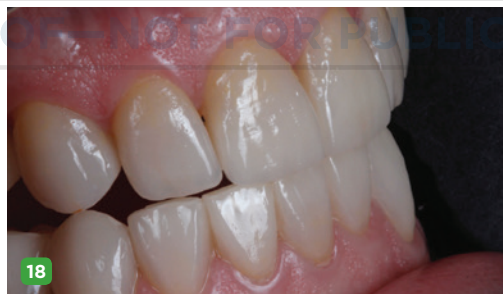
Fig 18. The patient's mouth at the four month follow-up appointment.
