Prosthetic Gingival Reconstruction in the Fixed Partial Restoration

Christian Coachman, DDS, CDT; David Garber, DMD; Maurice Salama, DMD; Henry Salama, DMD; Guilherme Cabral, DDS, CDT; and Marcelo Calamita, DDS

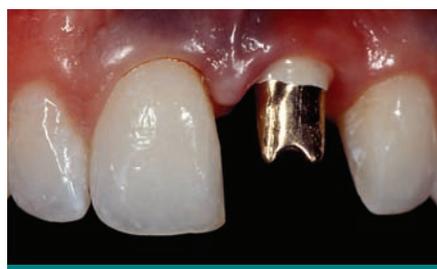
Figure 1 Initial placement of ceramic-metal augmented abutment after repeated osseous and connective-tissue grafts of the upper left central incisors. Clinical photograph from 10 years ago.

The patient presented having had, 10 years prior, osseous and soft-tissue grafts, followed by implant placement (Figure 1) with an alumina crown on tooth No. 9

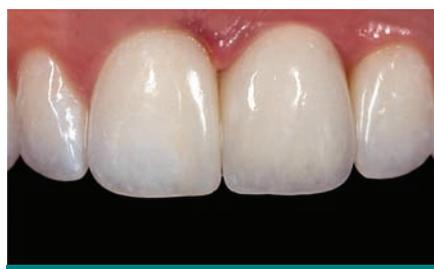
Figure 2 Placement of an all-ceramic crown showing resultant alteration in tooth form caused by loss of the papillae, ie, long restorative contact point between centrals. Clinical photograph from 10 years ago.

(Figure 2). She presented with misalignment of the incisal edges and papillae on tooth No. 9 and an altered free gingival margin level (Figure 3). It was suspected that her condition may have been caused by a late growth spurt of the maxillary complex or eruption of the adjacent teeth.

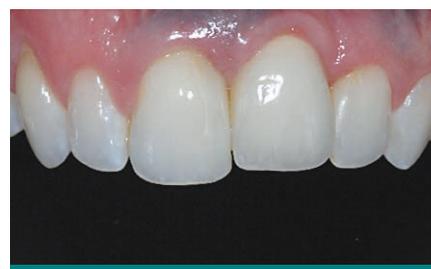
Figure 3 Patient presentation 10 years after the entail grafts and implant placement. The patient presented with a relative change in the position of tooth No. 9. This probably was caused by either a late growth spurt where the maxillary bone and teeth moved incisally while the implant crown stayed in the same position or eruption of the teeth adjacent to tooth No. 9. Notice the decrease in papillae height and the apical position of the gingival margin on tooth No. 9. These factors modified the esthetics of the restoration dramatically.

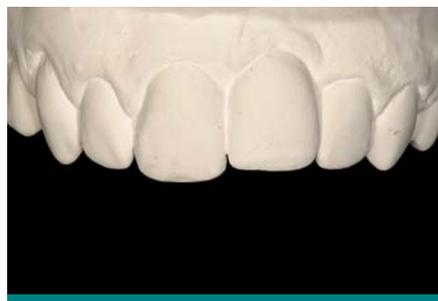
Figure 4 Preoperative study model showed all of the esthetic factors.

To plan this precise position for the crown margin on the abutment, a full-contour diagnostic wax-up to reproduce the ideal shape of the tooth was developed (Figure 4). This left room apically for the artificial gingiva to be developed. Pink composite was added over the crown

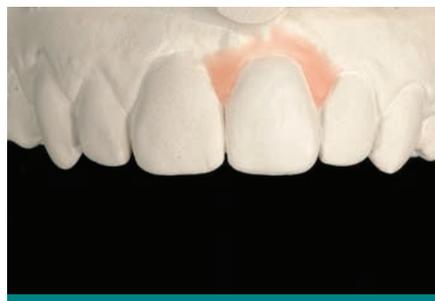
Figure 5 The diagnostic wax-up restoring the incisal and coronal harmony to tooth No. 9 and redeveloping the laboratory soft-tissue profiles in pink composite (wax also can be used) on the model's restorative gingival interface, ie, the mesial and distal papillae and new level to the free gingival margin.

wax-up to reproduce the missing soft tissue (Figure 5). This pink gingival composite mask was removable. The wax-up provided an exact simulation of where to position the ideal crown margin and restorative gingival interface on the abutment to develop a finish line barely subgingival relative to the artificial composite gingiva but supragingival relative to the remaining natural tissue (Figure 6 through Figure 9).

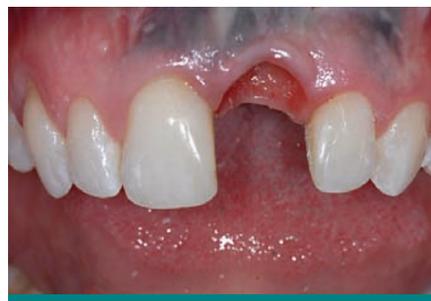
Figure 6 The original restoration was tapped out and removed.

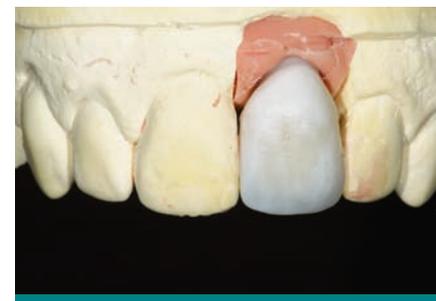
Figure 7 A full-contour wax-up of the crown was developed over the working model to guide in the design of the final abutment, coping, and restoration.

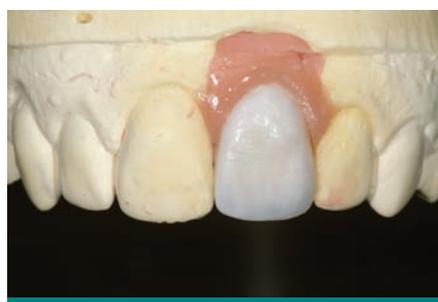
Figure 8 Pink composite was added to the wax-up, simulating the optimal form of the soft-tissue profiles and relocating the restorative gingival interface coronally.

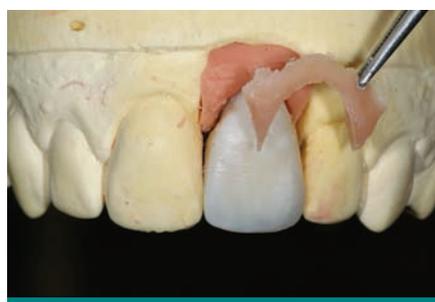
Figure 9 This pink composite was readily removable so that it could be used as a guide to the ceramic buildup.

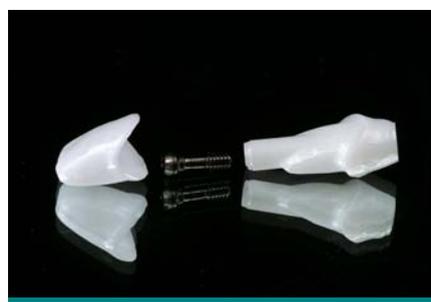
Figure 10 A zirconium abutment and crown coping were fabricated.

The abutment and coping were fabricated in zirconium (Procera[®], Nobel Biocare USA LLC, Yorba Linda, CA), and the buildup was made with Nobel Rondo[™] Ceramics (Nobel Biocare USA LLC) (Figure 10 through Figure 14). The challenge was matching the adjacent natural teeth. After finishing the buildup, the crown was tried in over the abutment, and then the shape and shade were completed and the crown glazed.

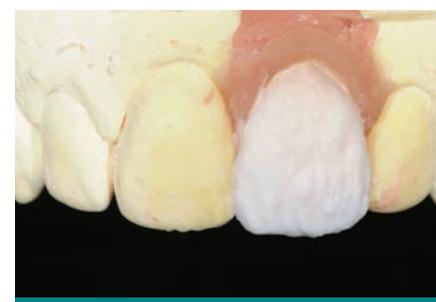
Figure 11 The ceramic buildup with the pink model composite in position.

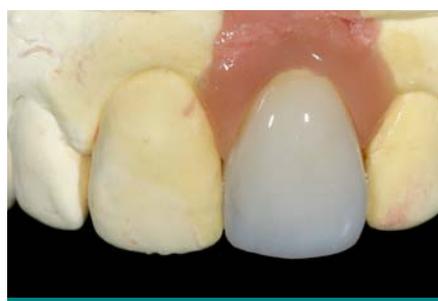
Figure 12 The completed composite ceramic crown surrounded by the simulated restorative gingival interface.

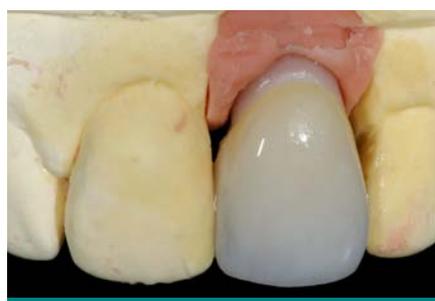
Figure 13 The ceramic crown with pink gingival simulation removed the deficiency of soft-tissue, resulting in an untoward esthetic "black triangle" and altering the gingival height.

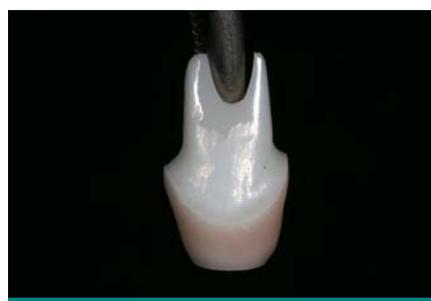
Figure 14 The subgingival contours of the zirconium abutment were overlaid with pink ceramic.

The abutment was prepared to receive the composite. A thin layer of pink ceramic was applied to the abutment as a bonding interface between the zirconium and the composite. Then, the ceramic surface of the abutment was sandblasted, etched, and silanated. Finally, it received a thin layer

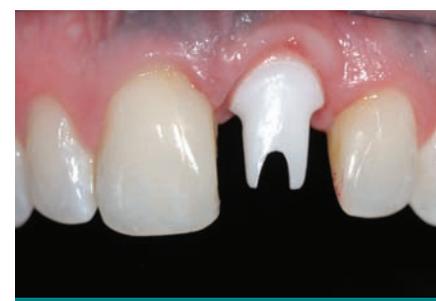
Figure 15 The zirconium abutment was screwed into position intraorally.

of flowable pink composite. The abutment was then placed in the mouth (Figure 15). The glazed crown was placed into position on the abutment so that the direct bonding of the gingival composite could be done instantly (Figure 16).

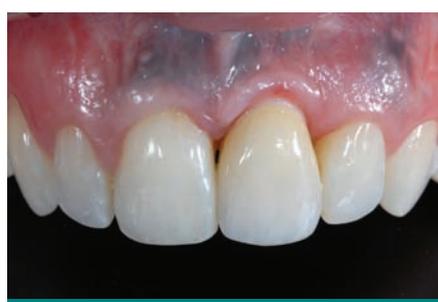
Figure 16 The two-piece abutment and crown in position. Note that the margin of the crown was supragingivally positioned just apical to the level of the adjacent incisor and slightly apical to the level of the potential composite gingival level.

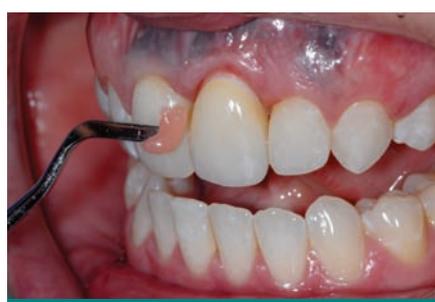
Figure 17 Pink composite was directly bonded intraorally to the abutment, with the crown in position to develop a perfect interface between the pink gingival composite, the crown, and the compromised site.

A direct composite technique was executed by adding small increments of pink composite to the abutment, trying to match the color, shape, and form of the natural gingiva (Figure 17). After the pink composite was completed, the crown was removed, and then the abutment with the pink composite attached was unscrewed.

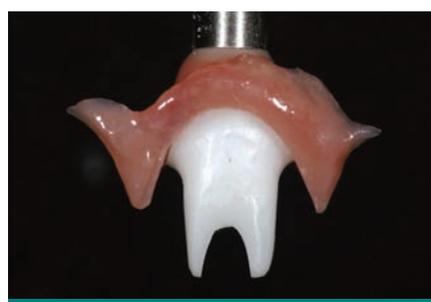
Figure 18 After removal from the mouth, the pink augmented abutment was finished chairside by removing the excess flash and sharp concavities and polishing the composite. (Finishing can also be performed in the dental laboratory.)

Outside of the mouth, extra pink composite was added to fill in undercuts and voids. Using a thin diamond bur, the edges were shaped and flashed and the excesses were removed. Polishing procedures were performed, followed by glazing of the pink composite (Figure 18). The abutment was then tried in to check the subtle esthetic nuances of the delicate interface between the natural and artificial gingiva (Figure 19). The ability to perform hygiene procedures also was checked, making sure that floss could slide through the entire interface between artificial gingiva, natural gingiva, and adjacent teeth (Figure 20

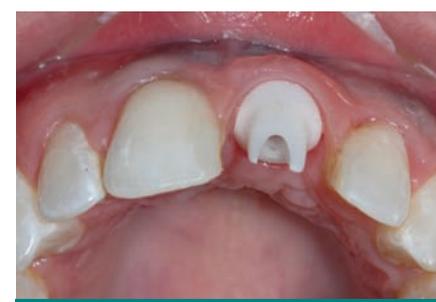
Figure 19 Occlusal view showing the redeveloped gingival profiles recouping the tissue loss.

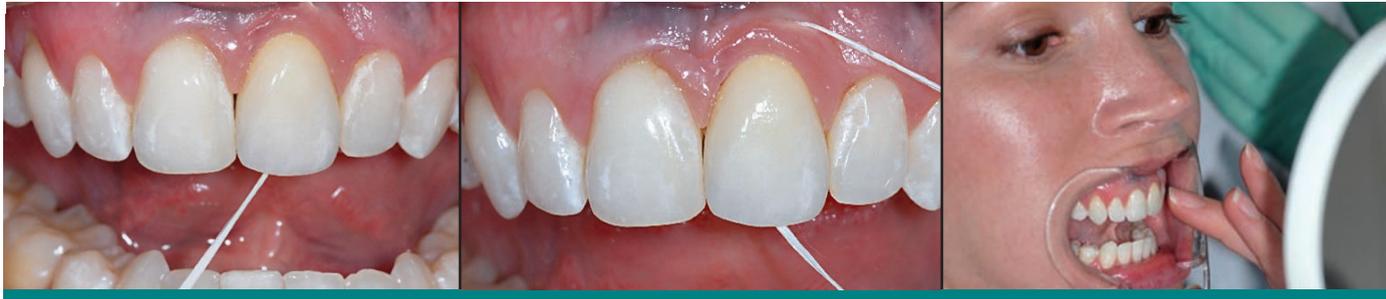
Figure 20 through 22 The restoration was designed to allow the patient to be able to remove plaque and debris accumulating at the soft tissue–restorative interface. Floss must pass readily through the contacts and over the flat or convex apical areas to be able to clean the convex restorative surfaces and passively contact the surface of the remaining soft tissues of the site. Maintenance is key for long-term successful pink restorations.

through Figure 22). It is essential to ensure that the patient will be able execute all of these hygiene procedures before final torquing of the “pink” abutment into position (Figure 23).

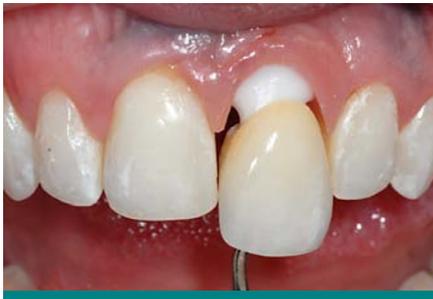
Figure 24 The crown was cemented in position over the abutment and restorative gingival profile.

After the abutment was in position, the crown was placed with retrievable cement (Figure 24 through Figure 28). A follow-up appointment was scheduled for 1 month posttreatment to check the health of the gingiva and efficiency of the hygiene procedures executed by the patient.

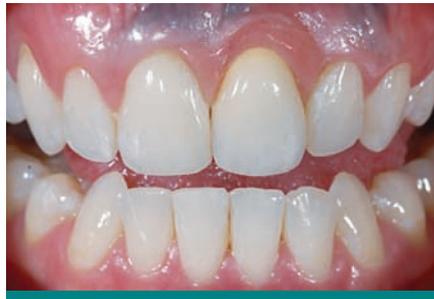
Figure 25 The crown was placed secondarily with a retrievable cement to provide for access to the abutment screw if necessary.

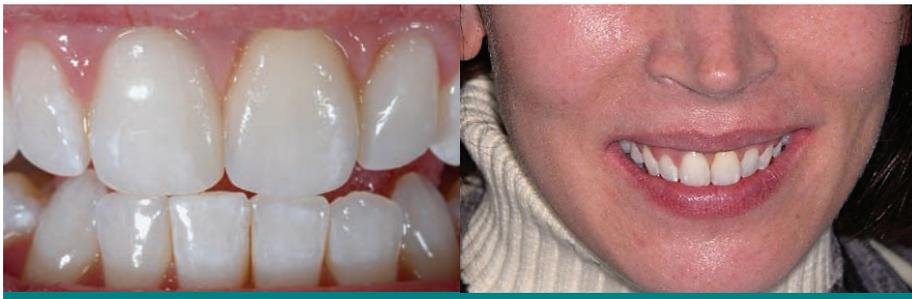
Figure 26 and 27 The final re-treatment results, with restored harmony to the smile line and soft-tissue profiles.

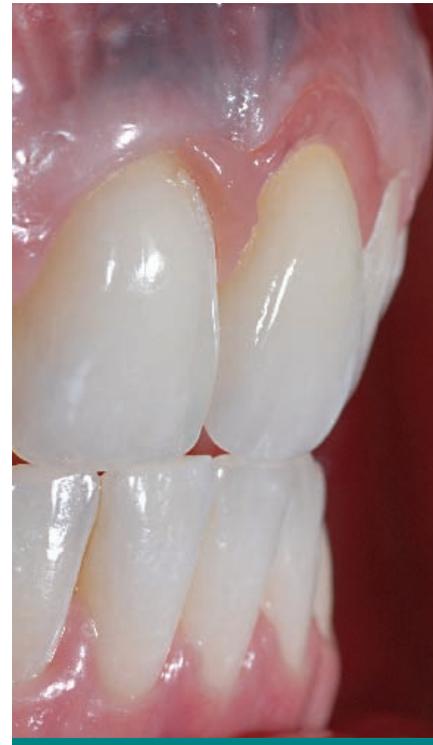
Figure 28 Intraoral lateral view of the final restorations—ceramic abutment, composite gingival restoration, and all-ceramic crown.

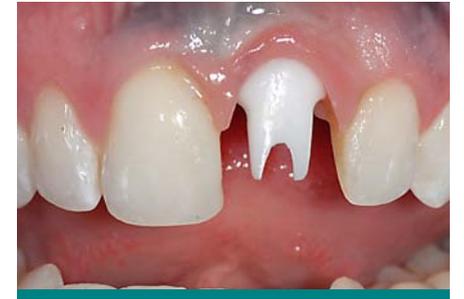
Figure 23 The “pink” abutment, finished, was torqued to 32 Ncm. Notice the blend between natural tissue and artificial composite gingiva.
