# New materials for a classic indication

Cementation of all-ceramic restorations using Variolink Esthetic  
Report by Eduardo Mahn and Juan Pablo Sánchez/Santiago (Chile)

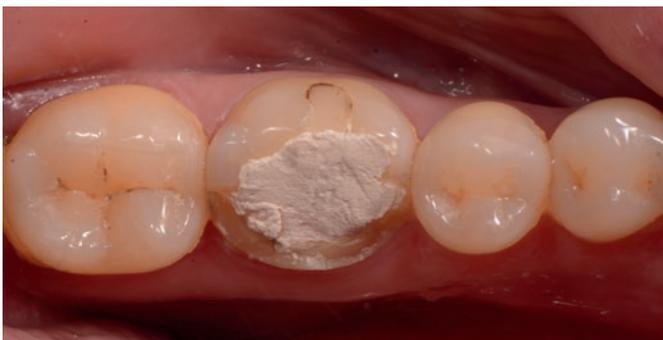
01 — Preoperative situation

A 45-year-old male patient presented to the practice with a restoration on tooth 46. The tooth had been endodontically treated and was temporized with a filling (Fig. 1). The temporary was removed, the tooth built up with Tetric N-Ceram Bulk Fill and then prepared for the crown restoration (Fig.2). An impression was taken with a one-step two-phase impression technique using putty and light-body silicone. After scanning the model, the crown was designed in the software suite (inLab, Dentsply Sirona) and milled from an IPS e.max® lithium disilicate block (Fig.3). After the crystallization firing the crown was stained and glazed (Fig.4).

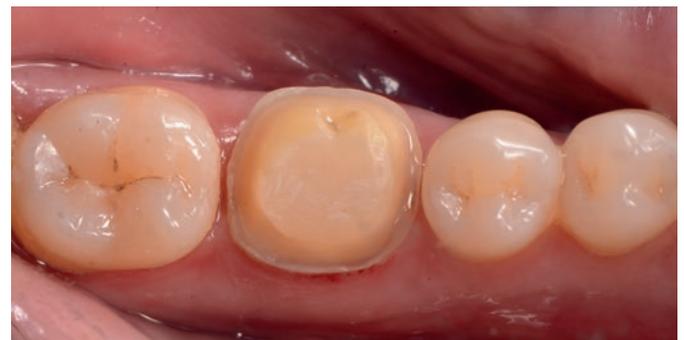
02 — Situation after composite build-up (Tetric N-Ceram Bulk Fill) and preparation

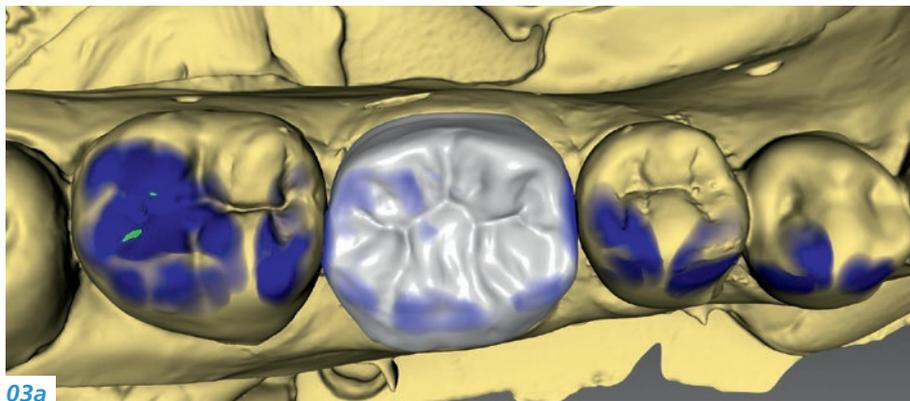
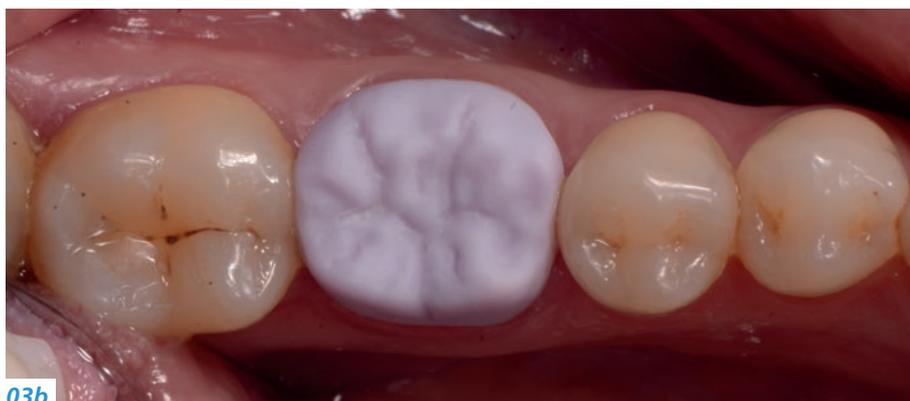
**03a and b** — Crown design in the software suite (Cerec inLab) and try-in before crystallization firing (IPS e.max)

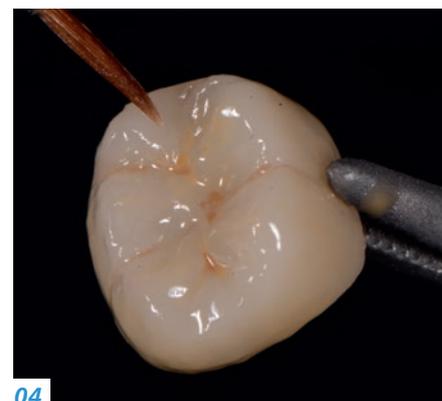
04

**04** — Characterized and glazed crown

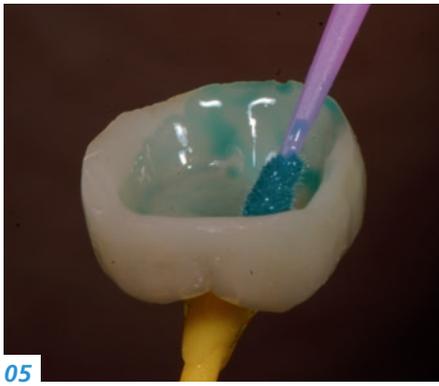
05

**05** — Etching and silanating with Monobond Etch & Prime

The next step was to etch and silanate the ceramic crown with the new glass-ceramic primer Monobond® Etch & Prime. This primer combines a ceramic etching and silanating component in one single material and therefore eliminates the need for the ceramic to undergo hydrofluoric acid etching (Fig.5). After the etching and silanating step, the crown was rinsed with water and dried. Then the isolated enamel was etched (Fig.6). The adhesive (Tetric N-Bond Universal) was applied and dispersed with a strong stream of air. The dual-curing (DC) version of the Variolink Esthetic luting composite was used for seating

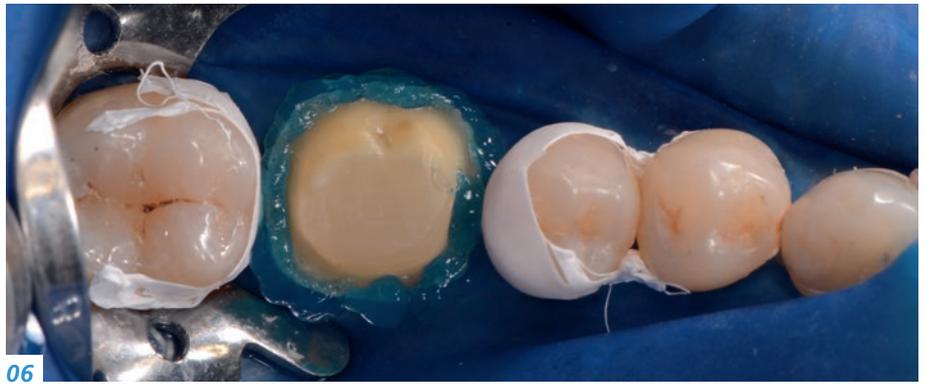
06

**06** — Enamel etching prior to the application of the adhesive

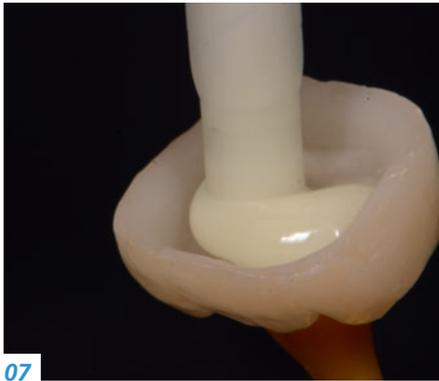
07

**07** — Applying Variolink Esthetic DC into the crown

due to the thickness of the crown and the low translucency of the ceramic material (Fig.7). The luting composite was applied into the crown. Then the restoration was seated (Fig.8) and light cured from each side for two seconds. Excess composite was easy to remove due to the Ivocerin photoinitiator, which provides a fast and thorough cure with a minimum amount of energy (Fig.9). For final polymerization, the restoration was light-cured from each quarter for 20 seconds (Fig.10). Figure 11 shows the oral situation after placement of the crown. Although the cement line is located above the gingival margin,

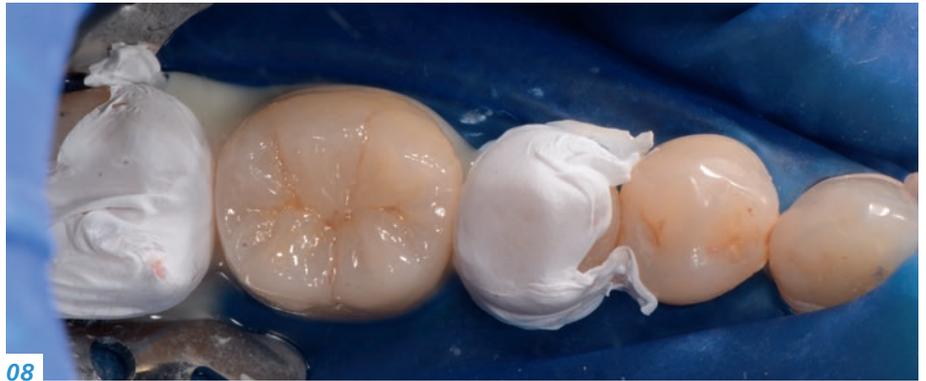
08

**08** — Placing the crown

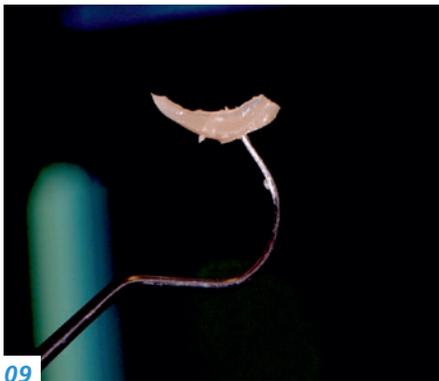
09

**09** — Excess removal is easily achieved due to the new technology based on the Ivocerin photoinitiator.

Excess can be polymerized en bloc and pulled off as a “ring” in one go with no uncured material left in touch with the tooth or crown (see Fig.9). In addition, the luting composite does not contain amine, which is another advantage. Amine may be implicated in a potential discolouration of the cement line over time.

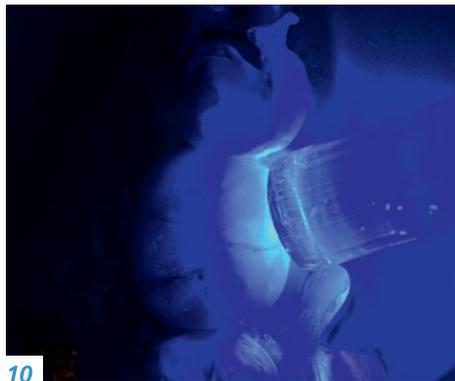
10

**10** — Final curing. Excess luting material was removed beforehand (quarter technique).

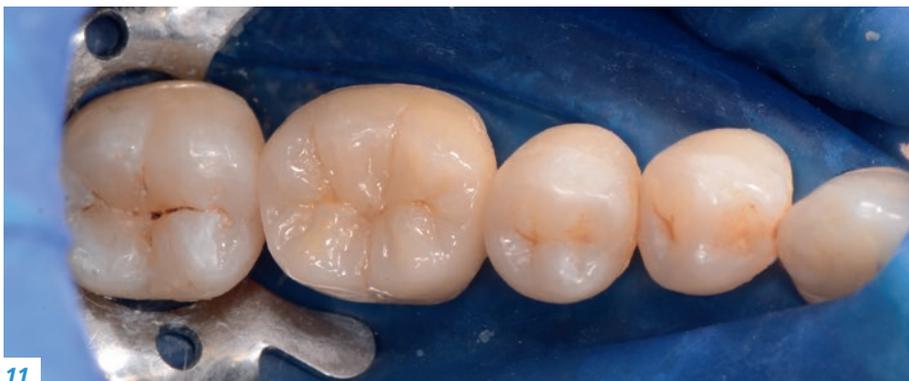
11

**11** — Seated crown after excess removal

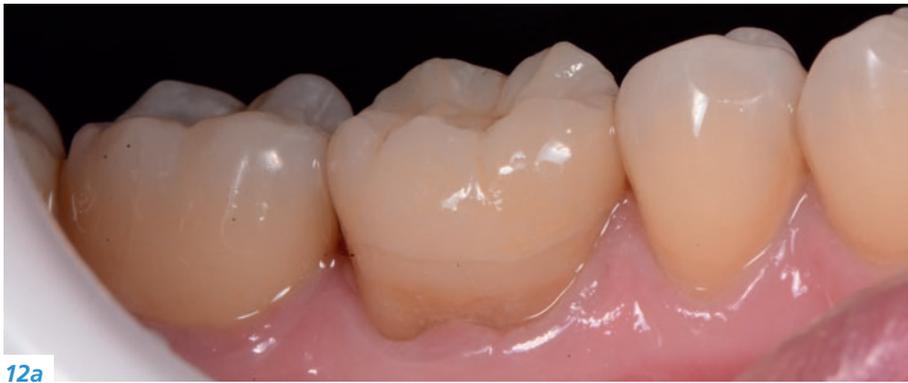
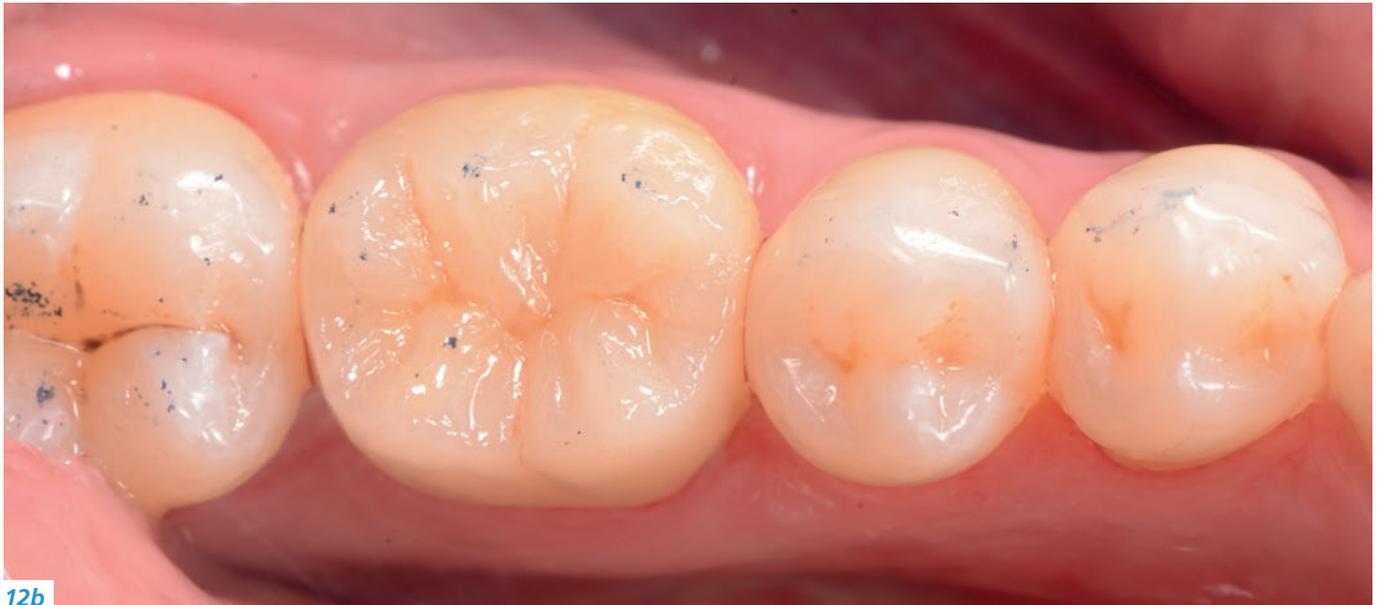
**12a and b** — Lateral and occlusal view of the completed restoration

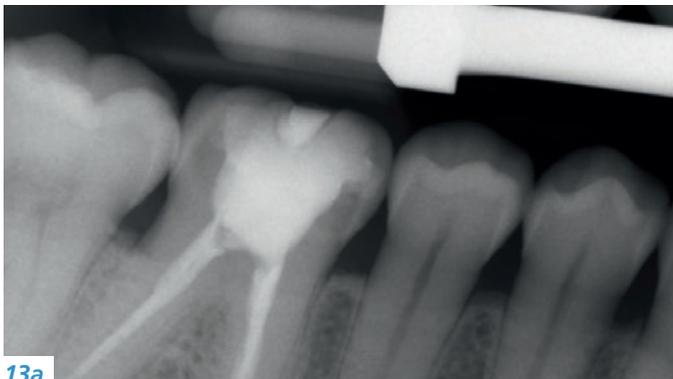
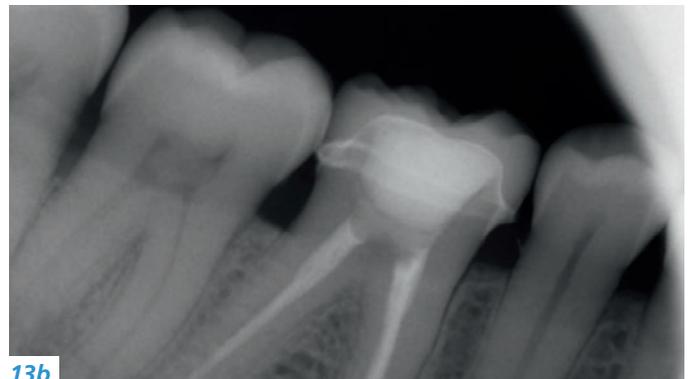
**13a and b** — X-ray control image before and after the treatment

it is not visible due to the favourable tone and opacity of the luting composite. Fig. 12 shows an X-ray control image of the restoration: the radiopaque build-up material and cement can be easily told from the tooth structure. This aspect is particularly important in situation where excess cement cannot be seen with the naked eye.
